Manhole Inspection Summary

Manhole # S11Q__007MH

Location Address: **3223 Strickland St**

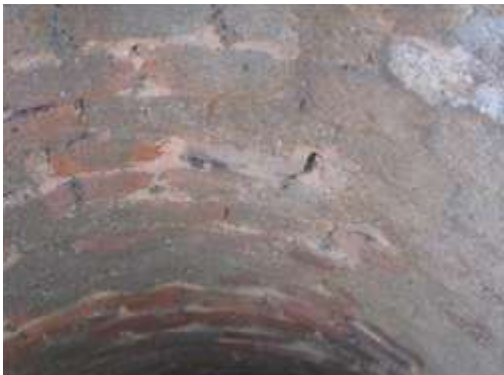
Defect 3

Corbel Material: **Brick** ☐ Parged Type: **Concentric/Eccentric**

Infiltration: ☐ None ☐ Joint ☐ Cracks ☐ Mortar ☐ Roots ☒ **Wall**

Infiltration along corbel wall, deteriorating mortar

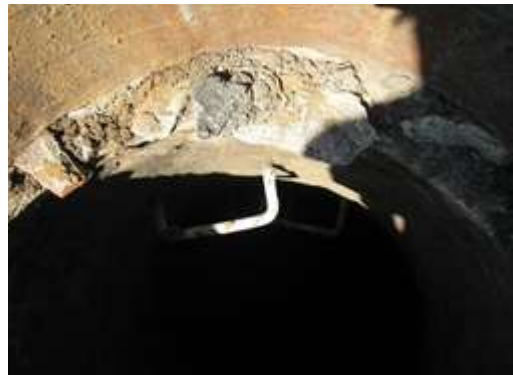
Defect 2

Chimney / Frame Adjustment ☒ Exists Material: **Brick** ☐ Parged Height: **3** (in.)

Condition: ☐ Sound ☐ Cracked ☐ Root Intrusion ☒ **Loose Brick** ☐ Deteriorated

Infiltration: ☐ None ☐ Joint ☐ Cracks ☐ Mortar ☐ Roots ☒ **Wall**

Loose bricks and mortar in chimney

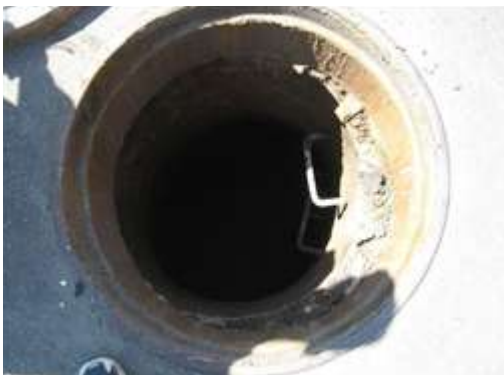
Defect 4

Frame Offset: **3** (in.) Condition: ☒ Sound ☐ Cracked ☐ Leaks

frame offset

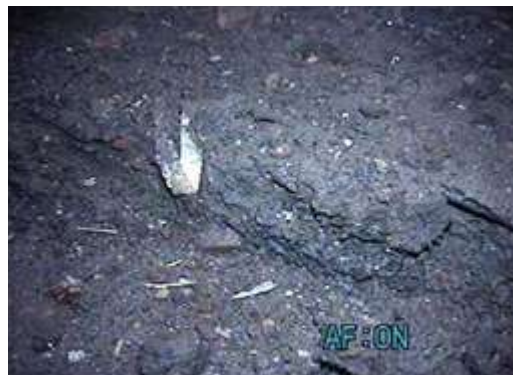
Defect 1

Condition: ☐ Sound ☐ Cracked ☐ Root Intrusion ☐ Deteriorated ☐ Leaks ☒ **Debris**

Heavy sediment on bench and in channel

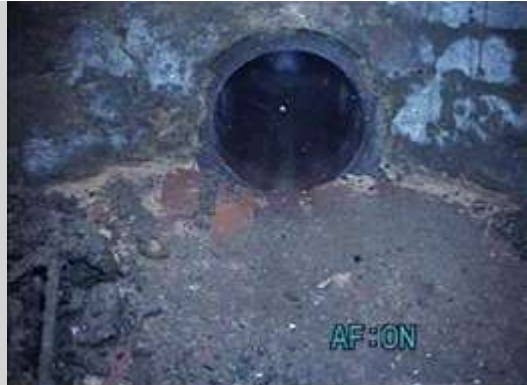
12 O'Clock Outflow

8 in. Circular Gravity Sewer
Pipe Out @ 12 O'Clock

Pipe Height: **8.4** (in.) Rod and Bar (Angled)
Pipe Material: **Clay** ☐ Pipe Lined
Invert Depth: **10.93** (ft.) Flow Characteristics: **Slow**
Deposits: ☒ None ☐ Mud ☐ Sludge ☐ Debris ☐ Grease
Silt Depth: **0** (in.) Deposits Extent:
Infiltration: **None** Pipe Seal Cond: **Sound**

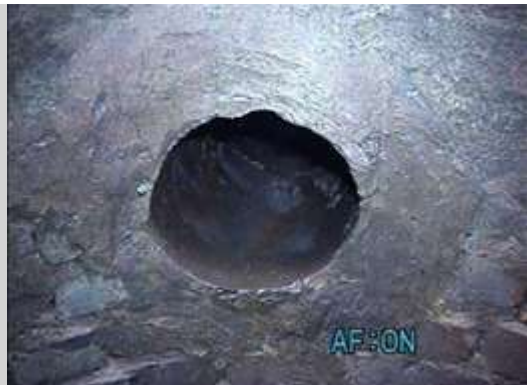
6 O'Clock Inflow

10 in. Circular Gravity Sewer
Pipe In @ 6 O'Clock

Pipe Height: **10.8** (in.) Rod and Bar (Angled)
Pipe Material: **Clay** ☐ Pipe Lined
Invert Depth: **7.72** (ft.) Flow Characteristics: **Slow**
Deposits: ☒ None ☐ Mud ☐ Sludge ☐ Debris ☐ Grease
Silt Depth: **0** (in.) Deposits Extent:
Infiltration: **None** Pipe Seal Cond: **Sound**
